January 29th, 2021

**Product:** Spektrum NX Transmitters (SPMR6775, SPMR6775EU, SPM6775, SPM6775EU, SPMR10100, SPMR10100EU)

**Issue:** Connecting through WiFi and checking for updates may cause some transmitters to lock up, requiring the transmitter to be restarted by pressing and holding the power button for 7-10 seconds, or unplugging the battery and reinstalling.

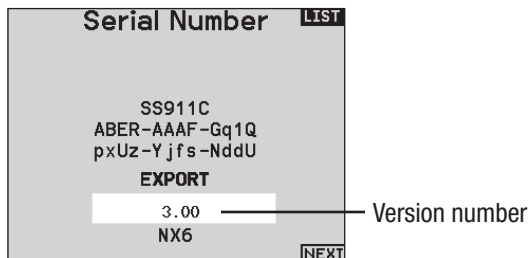
Check the firmware version of the transmitter by accessing the “About/Regulatory” menu in the System Setup list. The version is displayed at the bottom of the Serial Number screen. If the version number is prior to v3.03.03, follow the instructions below to download and update the firmware.

1. Download the latest firmware update for your transmitter from [www.spektrumrc.com](http://www.spektrumrc.com) to your PC or Mac. The file should be named SPMTX.SAX.
2. Power the transmitter off and on.
3. Connect the USB cable to the charge port on the transmitter and to your PC.
4. Press the scroll wheel to access the Function List menu.
5. Scroll down to the **System Setup** menu, and select **YES** to disable RF.
6. Scroll down to **USB Settings**.
7. From the USB Settings menu, select **Access Internal Storage**. After several seconds, your computer will recognize the transmitter as a removable drive.
8. Copy the updated firmware file to the transmitter from your computer.
9. Power off the transmitter and disconnect the USB cable.
10. Power on the transmitter. The transmitter will perform the firmware update on startup. This process may take several minutes to complete.
